**Subject:** RE: Belle Terre Multi-use Path Ph3

During my site visit yesterday and in response to your statement below that Cline has been busy repairing the washouts and the silt fences, the following areas were noted that have not had the silt fence repaired as you claim and still require immediate attention:

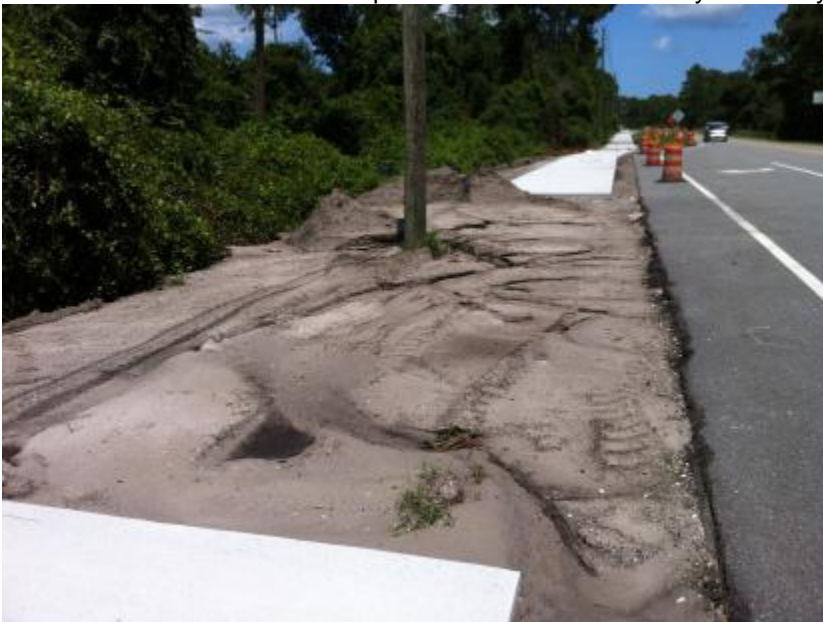
1. Sta. 13+70 has an existing power pole shown below that now has erosion at the base of the pole. There is still no silt fence repair at this location since my email to you on 8-2-12.

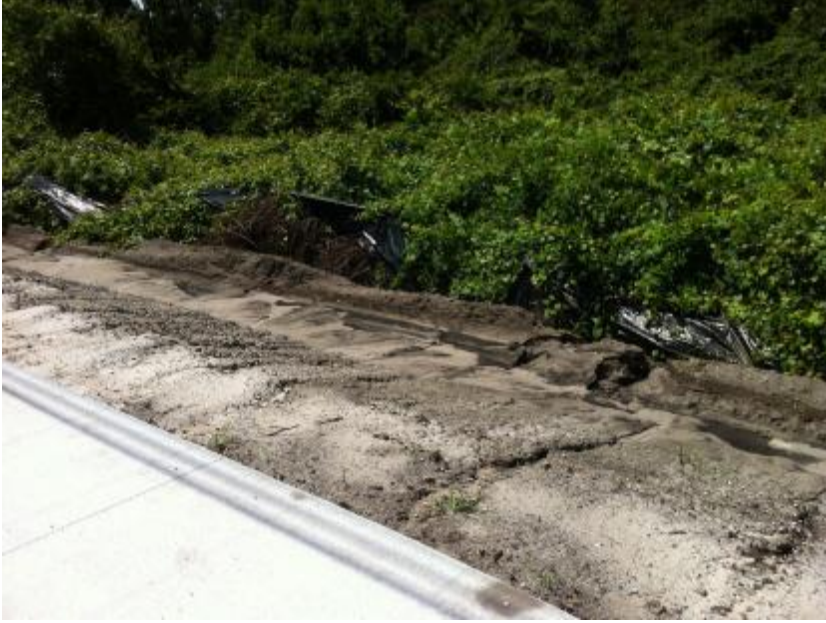
2. There is still no silt fence repair sta 13+85 to 20+35 below since noted to you in my 8-2-12 email (Item #4).

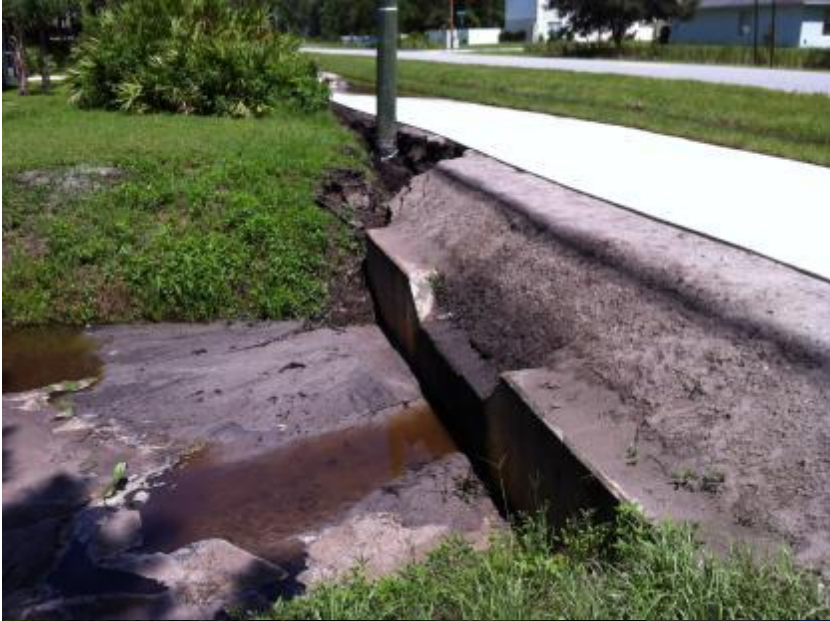
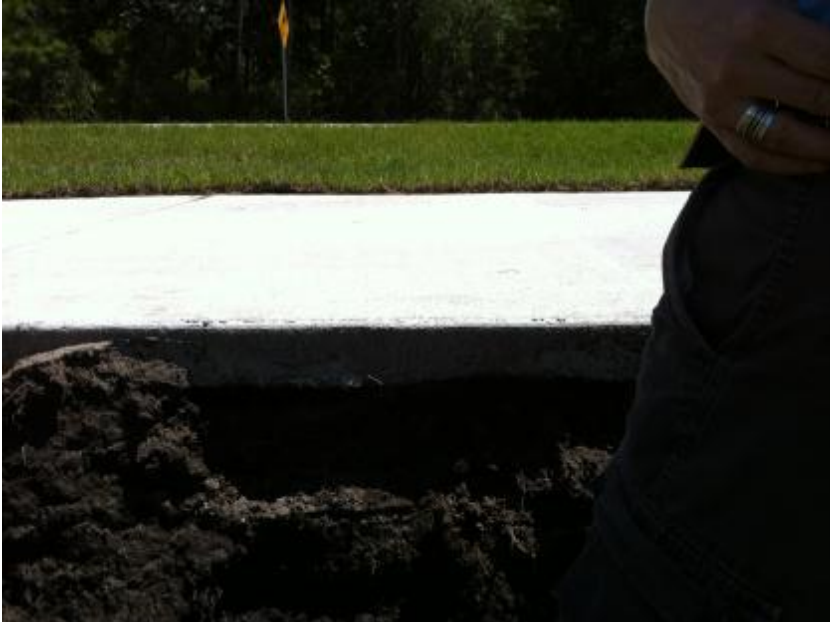
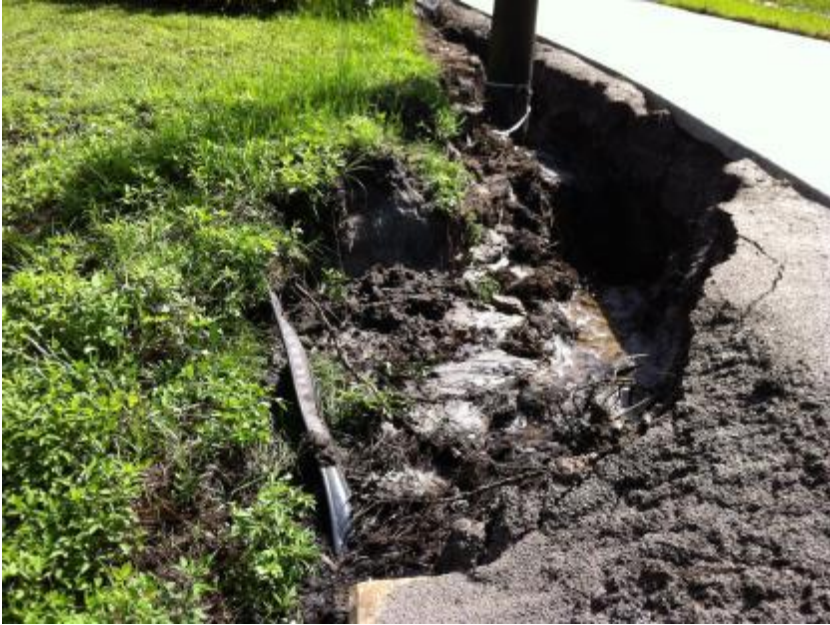
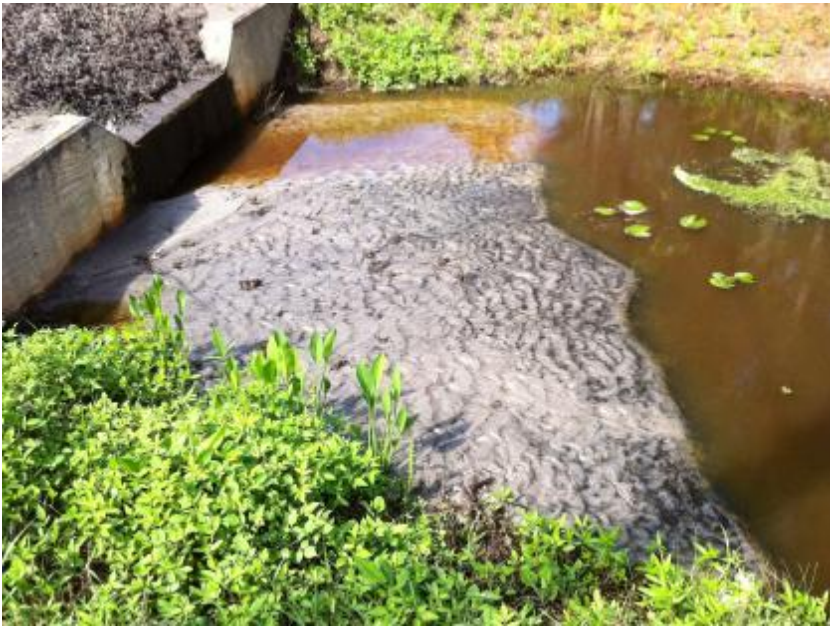
3. Sta 22+40 below has an existing headwall and flume that you were notified about in my emails on both 8-2-12 (Item #3) and on 8-9-12 (Item #3). The erosion is now approximately 3' deep beside the power pole because no silt fence or sod was placed to prevent the erosion. This area requires immediate repair including compaction of the embankment, and excavation of the silt in the swale. The silt has filled the swale to within a few inches of the top of the flume preventing the storm water from flowing properly. I am standing in the 3' hole beside your sidewalk in the second picture to show you the depth. The third and fourth pictures were taken this morning showing the erosion is now over 3 1/2' deep and 6' wide. The silt has carried down the swale and is built up not only at the Belle Terre end, but also against the flume at the Kalamazoo Trail end as well. All of this silt in this swale will need to be excavated by Cline. As you can see the power pole appears to be starting to lean into the hole since yesterday's photo.

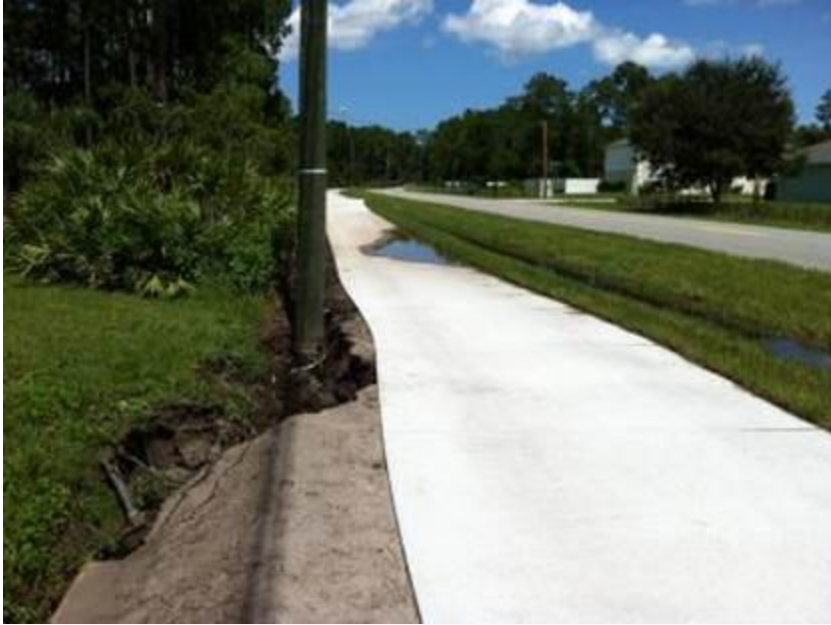
4. Sta 23+00 has standing water on sidewalk as shown by yesterday's photo below:

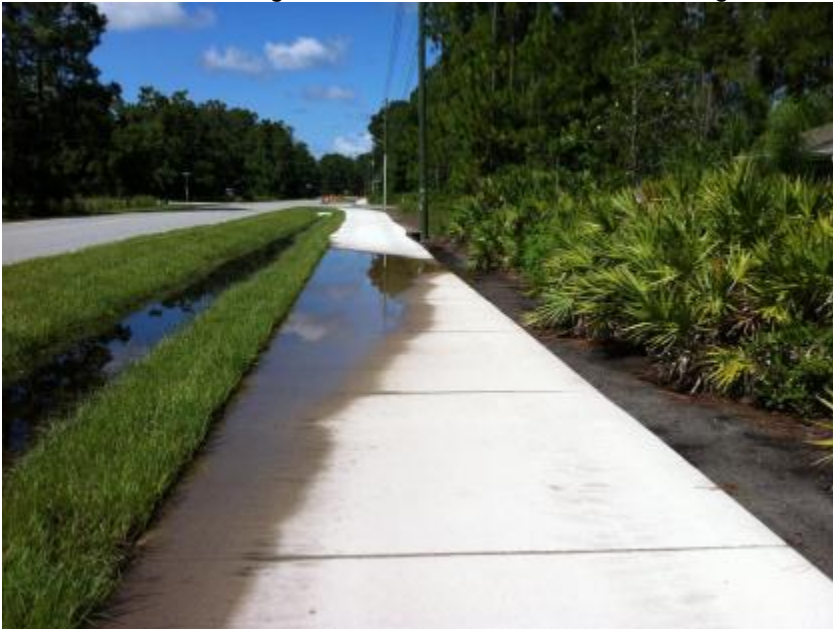
5. Sta 22+00 Standing water on sidewalk taken this morning shown below:

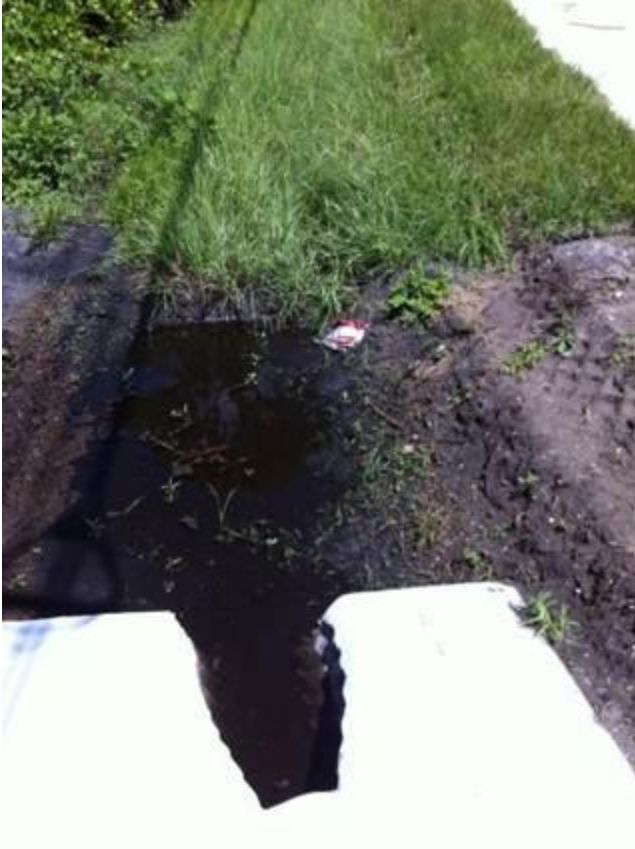
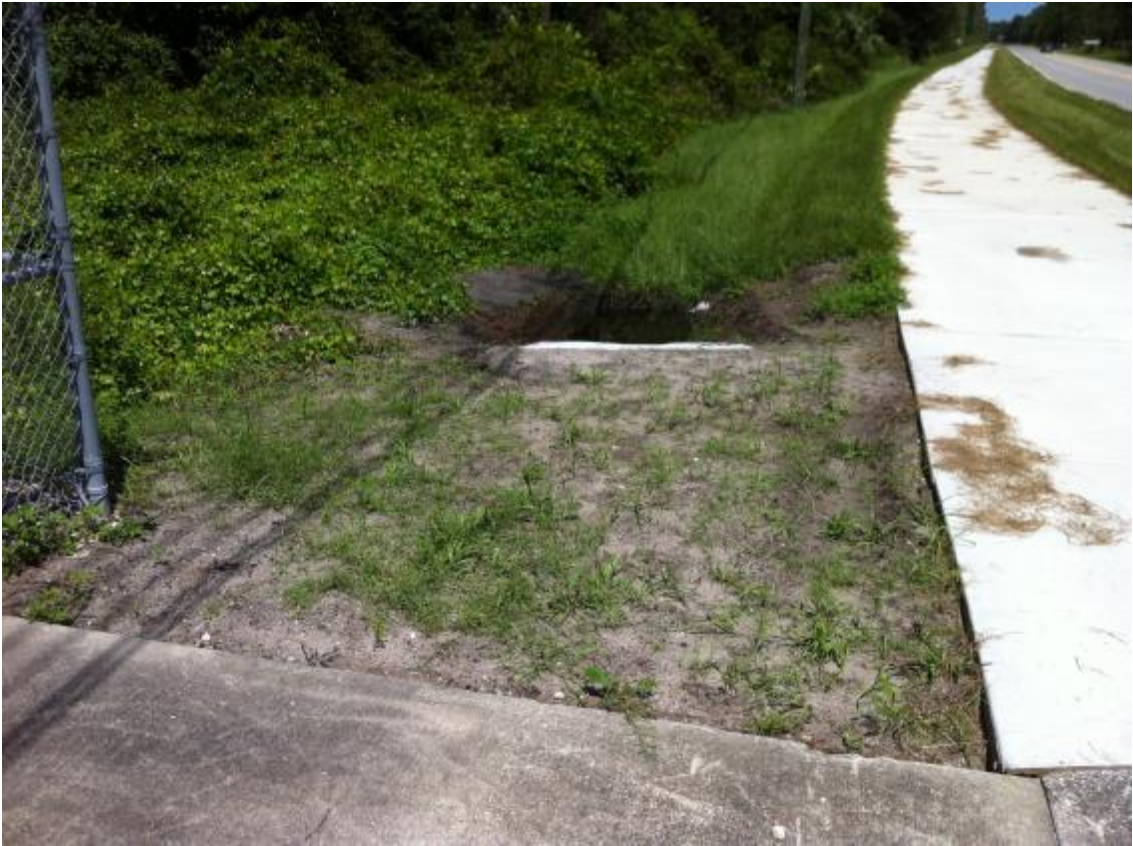
6. Sta 27+70 to 28+50 Below- Residential yard flooded and water held back from swale by elevation of sidewalk. EOR needs to check elevations at this location and provide revision to correct drainage problem.
7. Sta 32+25 Density Test Failed (see attached). Pictures taken yesterday at this location. Make corrections and notify Bechtol when area is ready for a density retest.

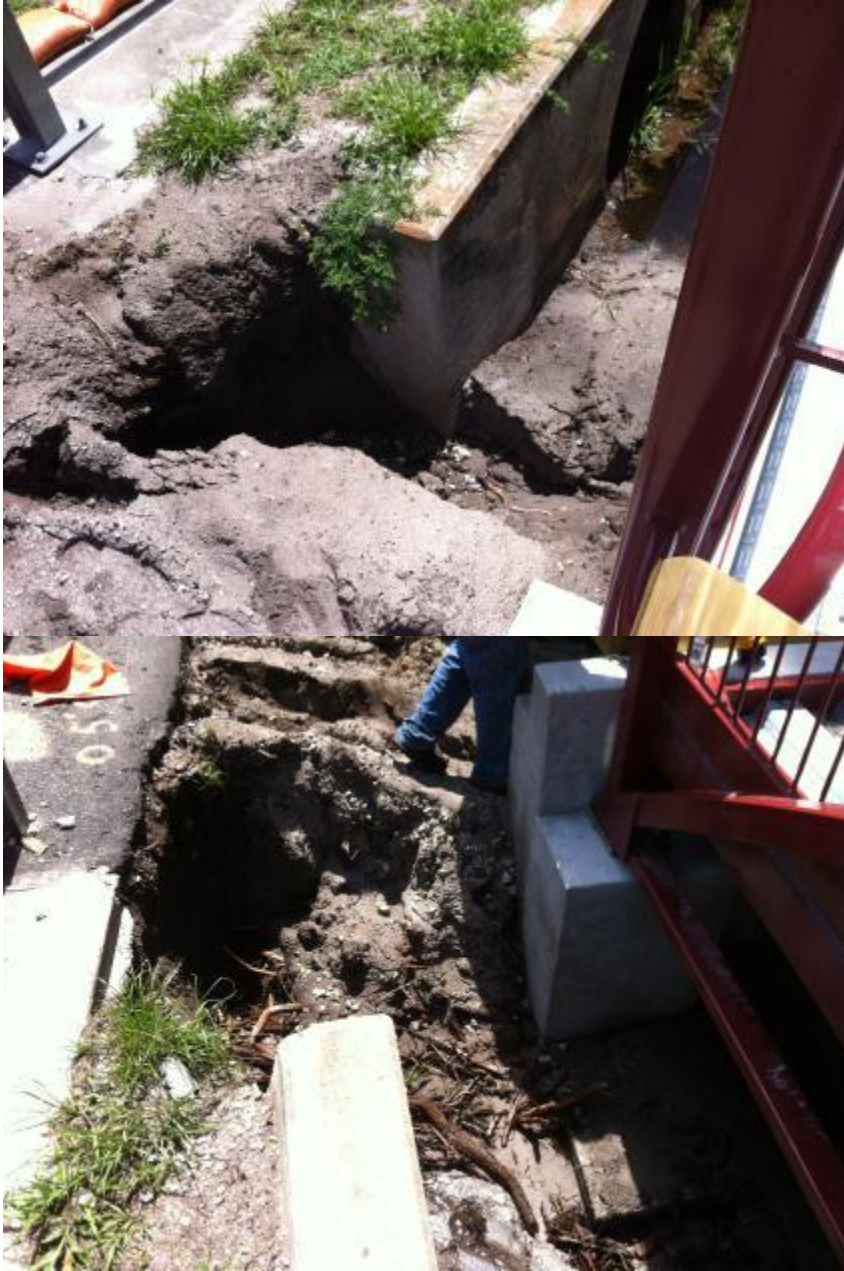
8. Sta 67+00 to 70+50 – This is a repeat urgent request for Cline to take immediate corrective measures to remedy the washout situation at the Benton Harbor bridge. Review my emails 8-2-12 (Item #1) and 8-9-12 (Item #2). Photos taken yesterday below show the seriousness of the erosion immediately adjacent to the roadway shoulder where the dropoff/washout is now almost 3-4' deep and beginning to undermine guardrail.

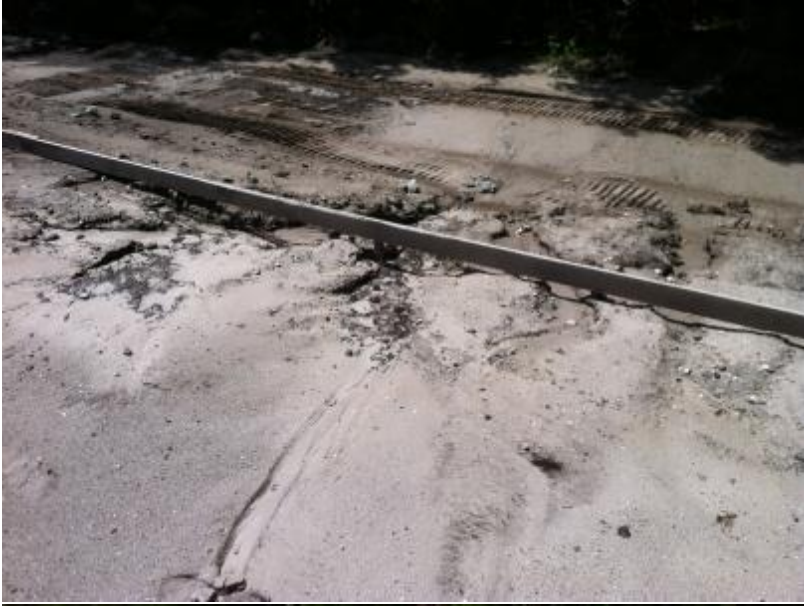
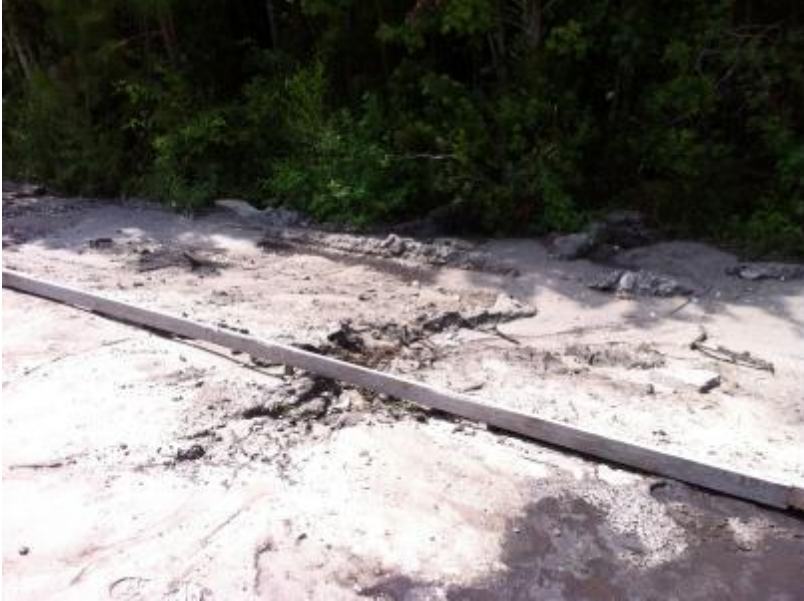
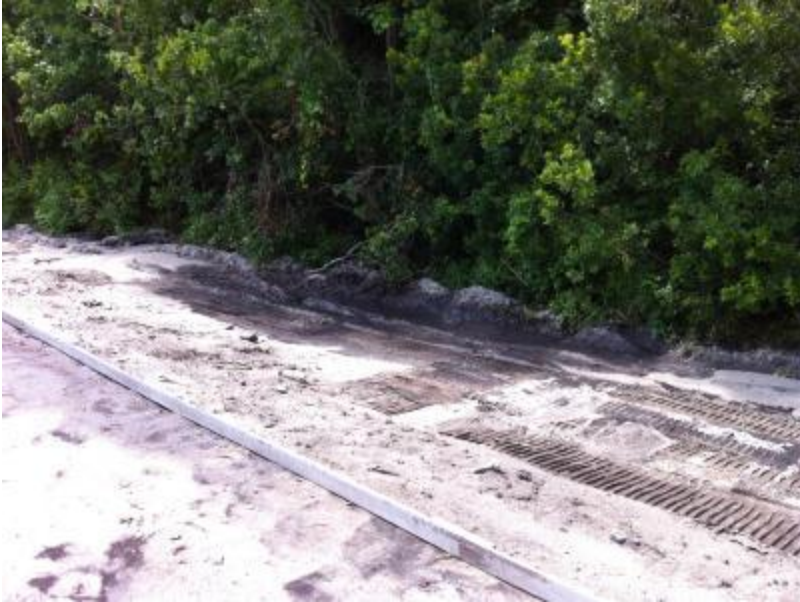
9. Sta 70+50 to 71+50 Your response is below to my email of 8-9-12, and again this area is shown as of yesterday. And again Cline did not install silt fence as required so there is further washout of this area since they built it back up without compaction on Tuesday 8-14-12. These photos clearly show no silt fence has been installed. Furthermore this area is listed as a wetland. Per our Senior Environmental Planner, Denise Bevan, "all sediment in wetlands shall be removed by hand methods and tools to pre-impact condition/natural state. No machinery can be used." This area failed an inspection for silt fence on 7-10-12 and has not had the silt fence replaced/corrected since then.

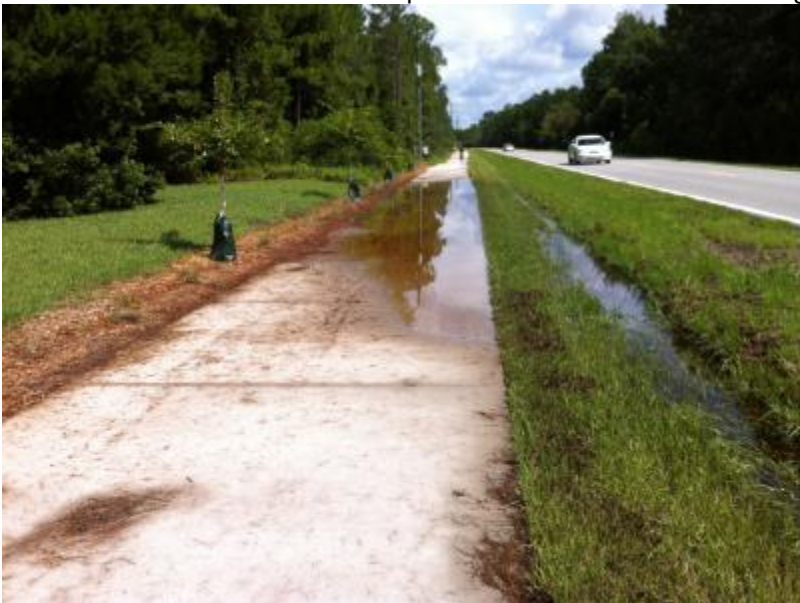
10. Sta 139+00 to 140+00 – Flooding across sidewalk into residential lots. EOR needs to check elevations at this location and provide revision to correct drainage problem:

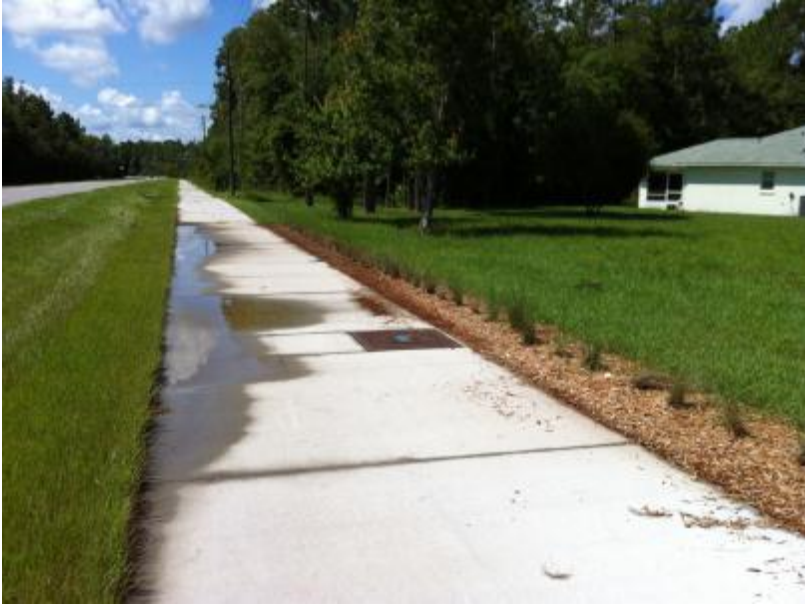
11. Sta 187+00 to 189+00 – Flooding again at this resident's location shown below. The water is standing on the sidewalk and across this resident's back yard. This is the same area reviewed during the site inspection on June 20, 2012 where the EOR was to review and provide design for correction. EOR needs to check elevations at this location and provide revision to correct drainage problem.

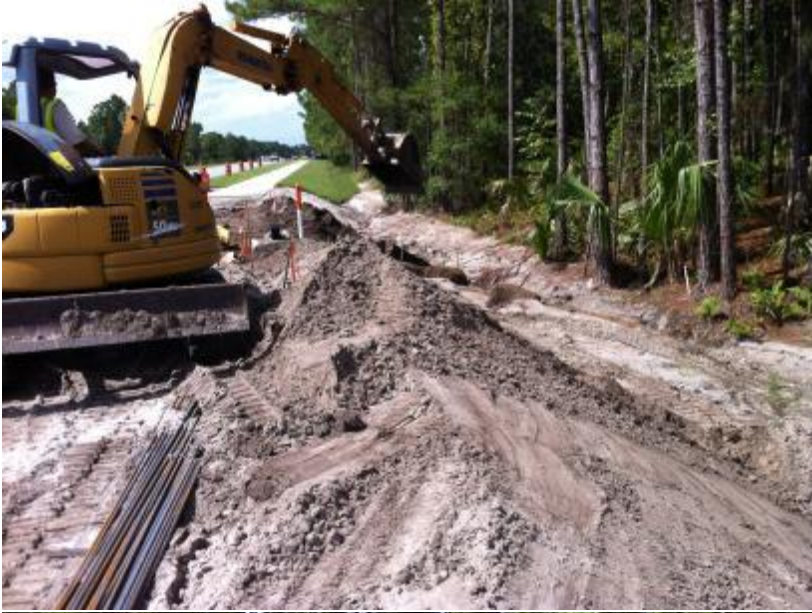
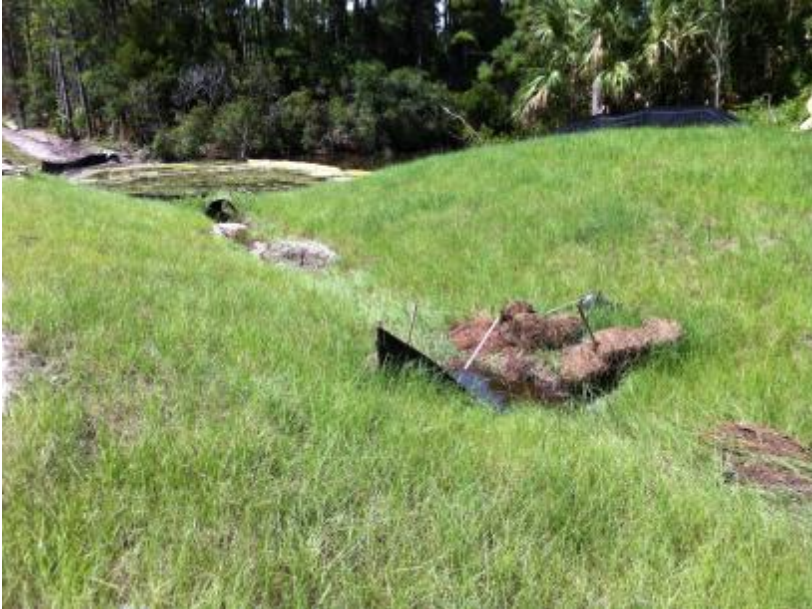
12. Both sets of hay bales have been compromised for several weeks north and south of the Pine Grove Waterway.

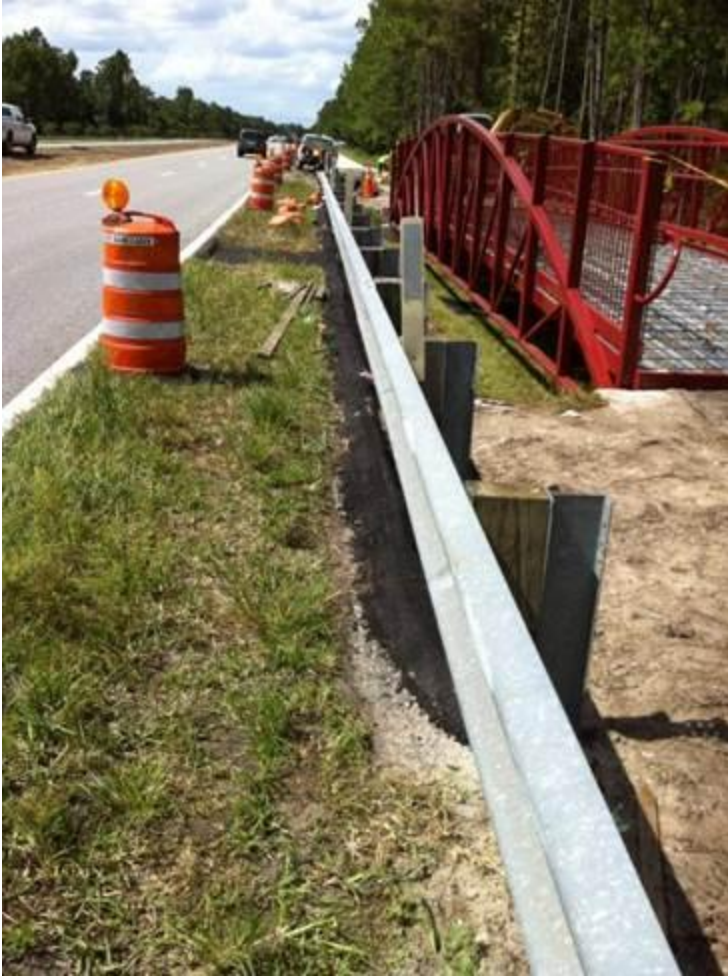
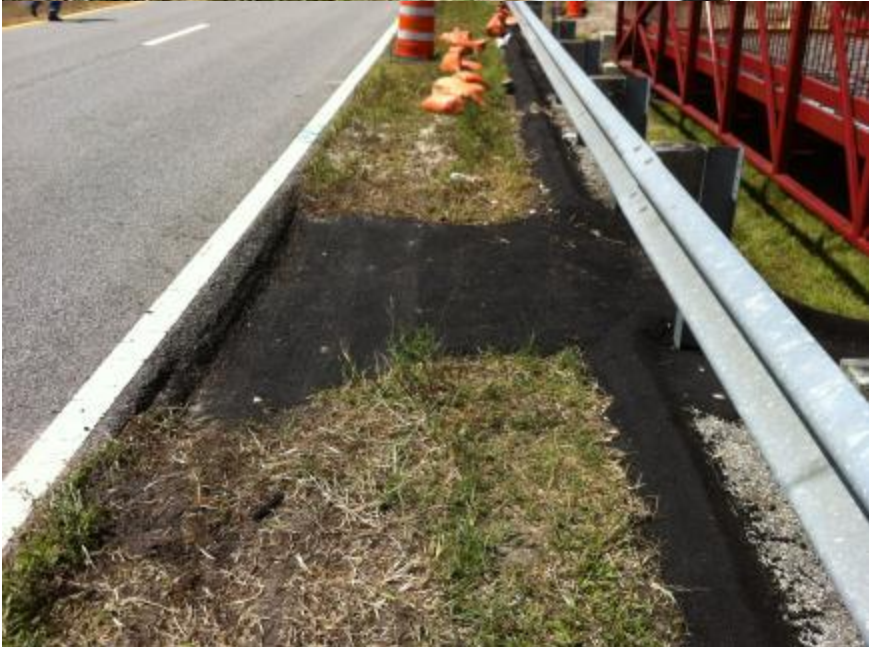
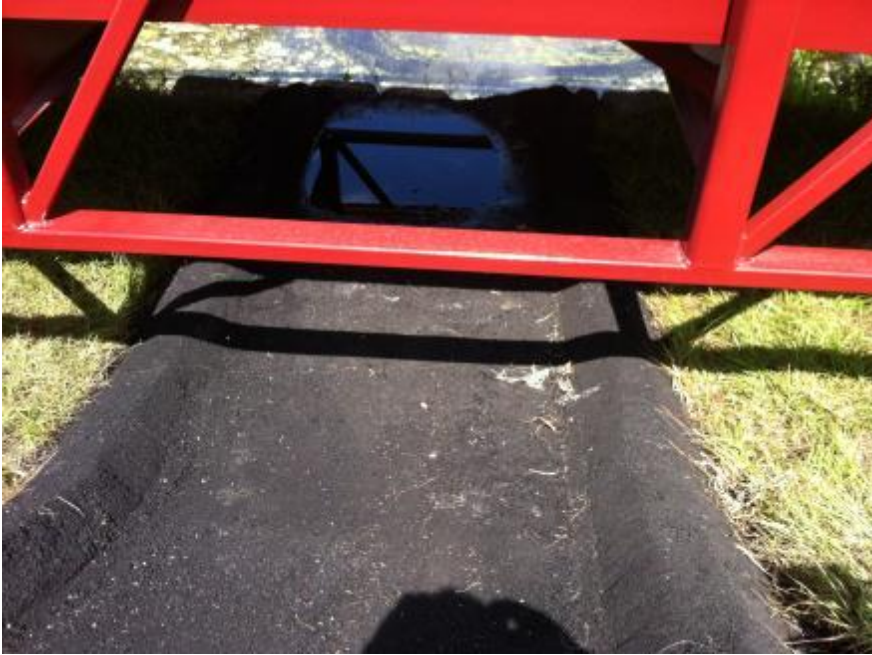
13. Sta 347+75 - Cline removed a spillway located on the east side of Belle Terre Parkway that extended from the shoulder of Belle Terre Parkway to Pine Grove Waterway. Cline removed this existing flume without the City's knowledge or authorization and subsequently installed an asphalt curb and flume in its place. No inspections were called to inspect their work. No RFI were sent to the City. No plan details were prepared for this installation. Hap Cameron, with Cline, stated that the existing flume elevation was too high. Per the City's Engineering Department, asphalt spillways are not acceptable. Spillway needed to be concrete.

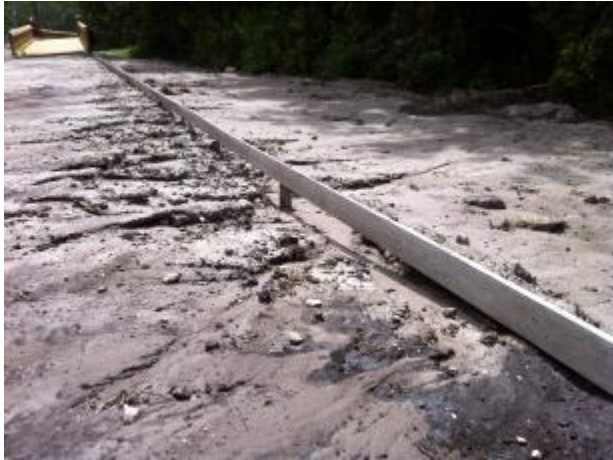
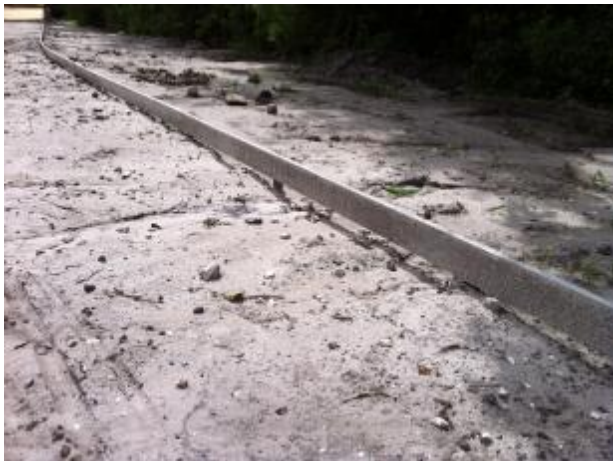
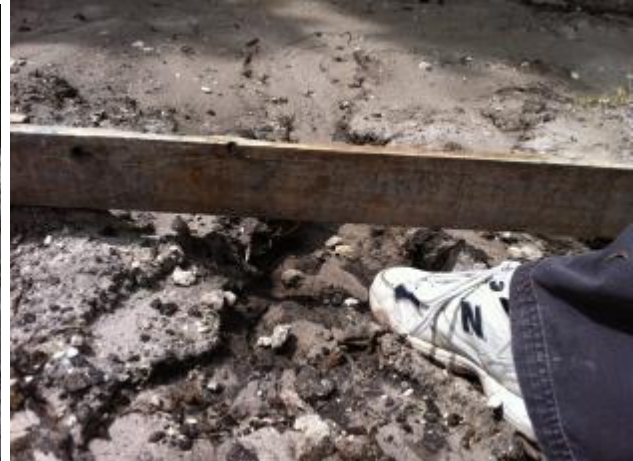
Attached below are photos of the typical washouts that have been occurring along this Belle Terre project. The plan details on Sheet G-4 shows a 6" compact subgrade to 95% extending 1' beyond both sides of the width of the concrete pathway. This is the detail that was approved by FDOT. CPH as the EOR needs to provide direction as how to correct erosion areas and obtain compaction as well as testing requirements to comply with FDOT specifications.

These photos were taken Wednesday afternoon, 8-8-12, prior to the rain event.

Cline's response to our request for them to remove the form boards, backfill to elevation, re-compact, and re-test for density, is listed below.

Item #6 Areas eroded around form boards will be filled and compacted. The form board removal is not required. Densities have passed in this area. If the City wants to verify the density of a 2" deep wash out then that is up to you.

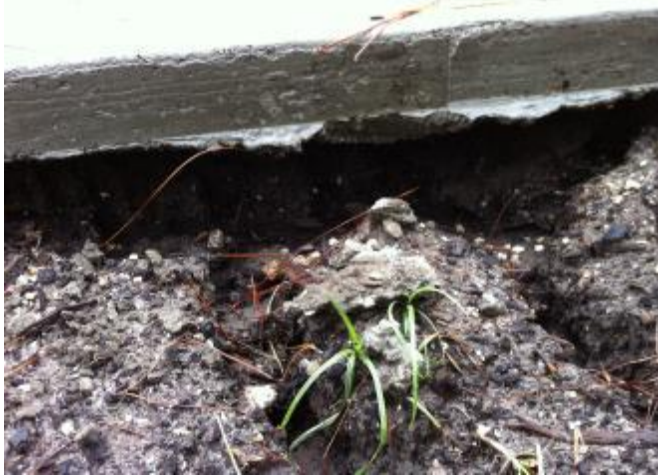
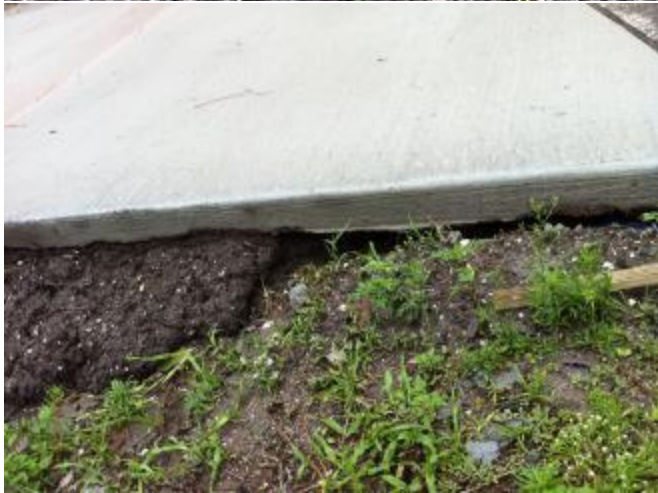
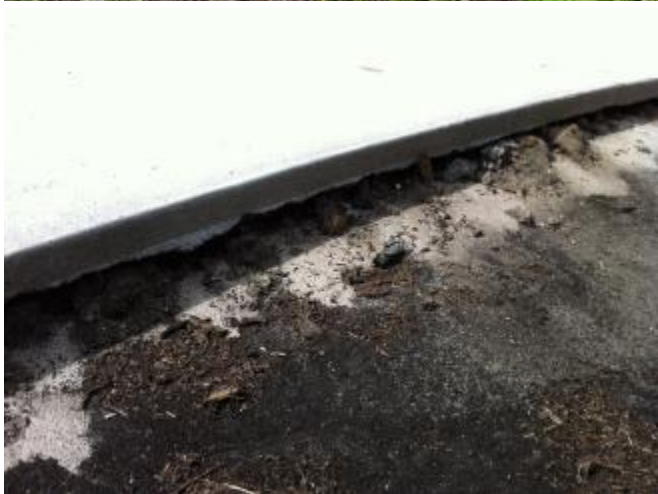
A second issue has been the washout and undermining beneath the edges of the pathway after the pathway has been poured. Pictures below were taken of two different sections a month apart.

Cline's repair to date has been to backfill with loose soil and shove it in with their shovels and feet as observed on two occasions so far. The City has concerns that this does not meet specification and density requirements. Please advise the proper procedure for repair to achieve compaction density requirements in the case of undermining of the edges of the pathway. Click on the following link to show their repair technique from this morning; <https://www.yousendit.com/download/TEhYS3hVNXZ6RS92WnNUQw>
